## **Cluster-29, Unit no.98 to 99**

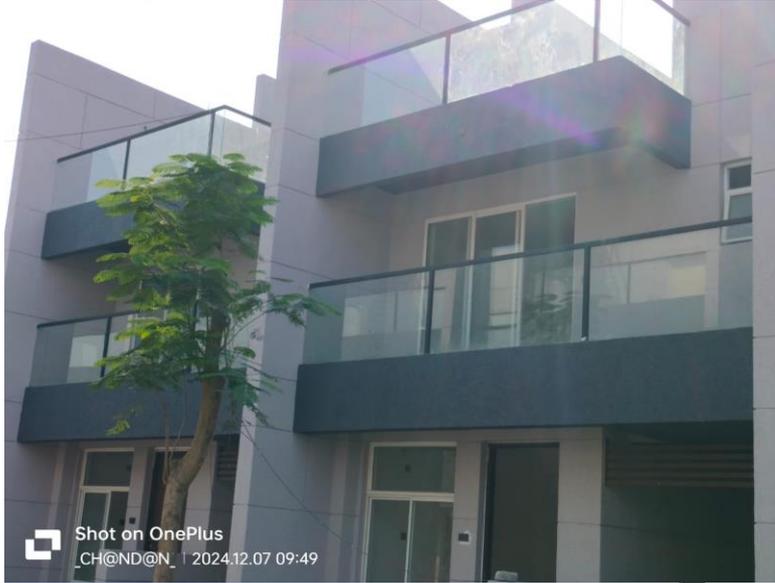
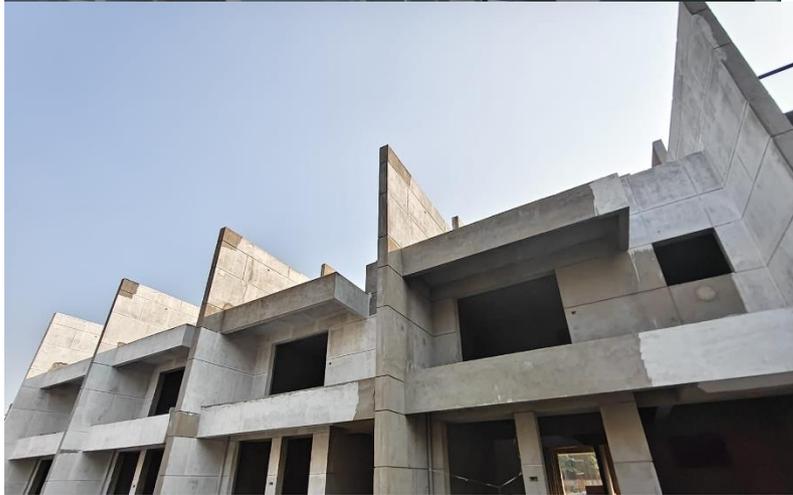
Sub structure is completed.

Ground floor slab is completed.

Brick work is completed.

1st floor slab completed.

Roof slab is completed.

Internal Electrical work in completed.

Plaster work is completed.

Plumbing work is in completed.

Flooring work is in completed.

Finishing Work is in completed.

External paint is in completed.
