Cluster-30, Unit no.93 to 97

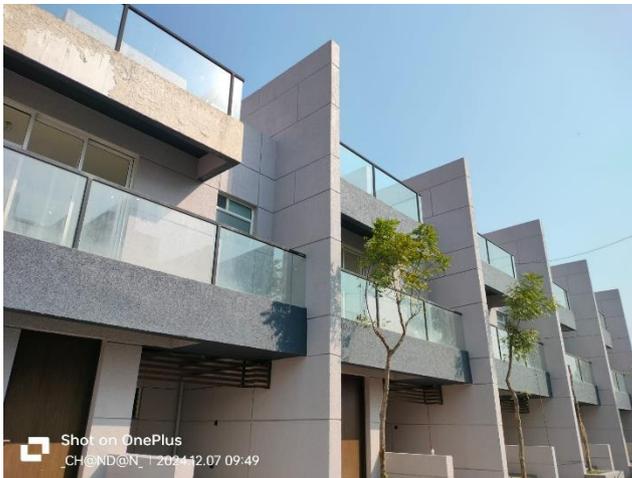
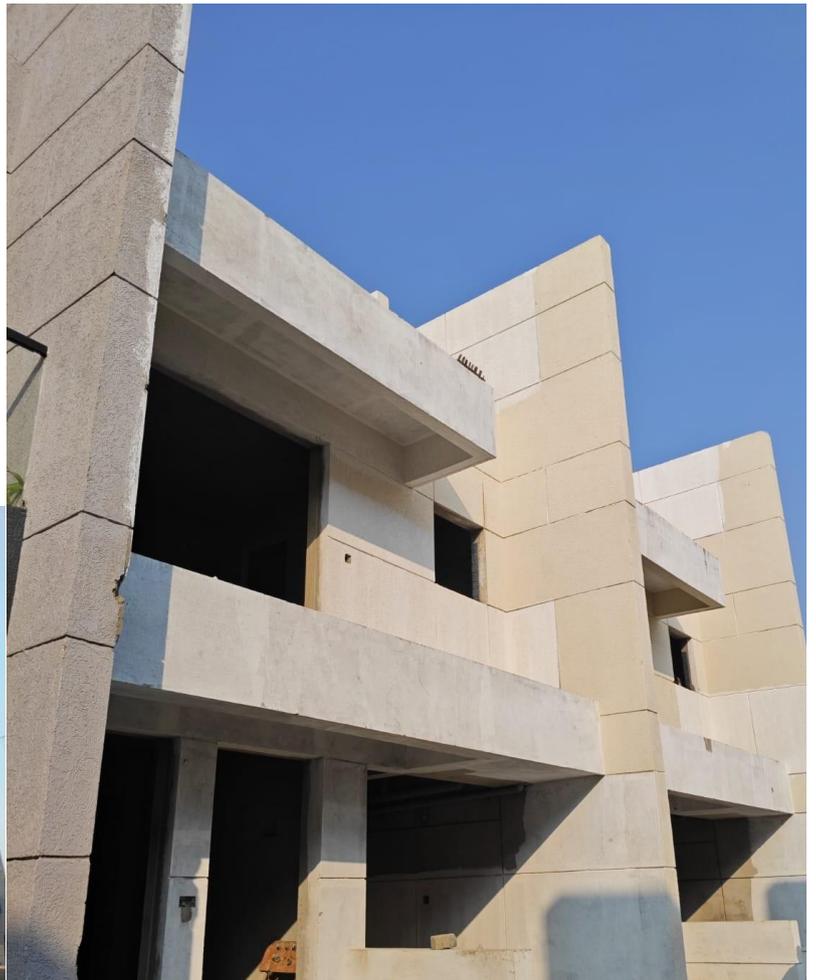
Substructure work completed.

Ground floor slab completed.

1st floor slab completed.

Roof slab is completed.

Brick work is completed.

Internal Electrical work in completed.

Plaster work is completed.

Plumbing work is in completed.

Anti termite work completed.

Waterproofing completed.

Flooring work is in completed.(93 to 97)

Finishing work is in completed.

External paint is in completed.
