Cluster-33,Unit no. 60 to 62

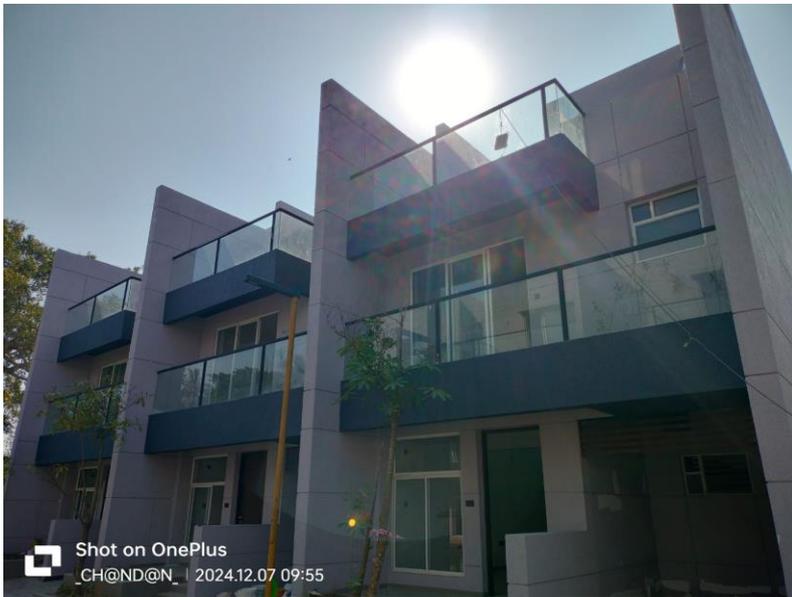
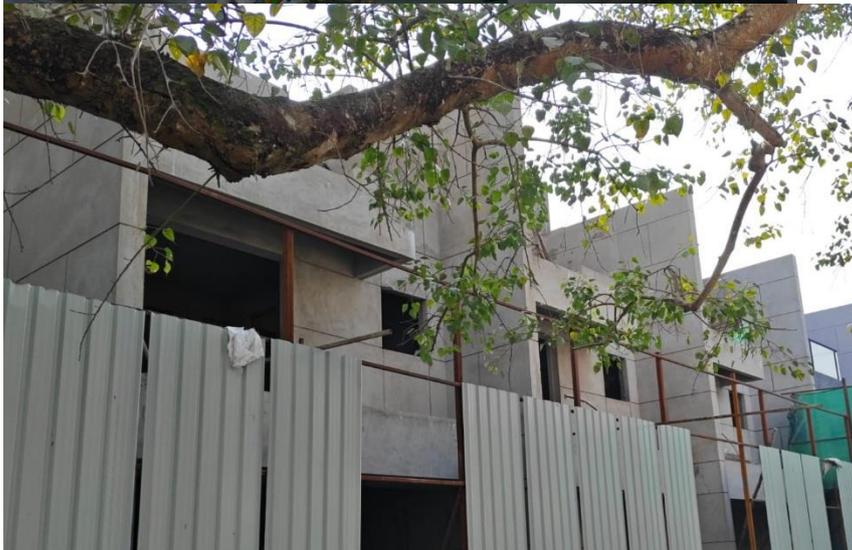
Civil substructure works foundation completed.

Ground floor slab completed.

1st floor slab completed.

Brickwork work in completed.

Roof slab is completed.

Internal Electrical work in completed.

Plastering work is done.

Plumbing work is in completed.

Anti termite work completed.

Waterproofing is completed.

Flooring work is in completed.

Finishing work is on completed.

External paint is in completed.
